NZR's Dsa CLASS

20 locomotives. NZR service 1953-1986.

Drewry Works numbers 2414-2433.

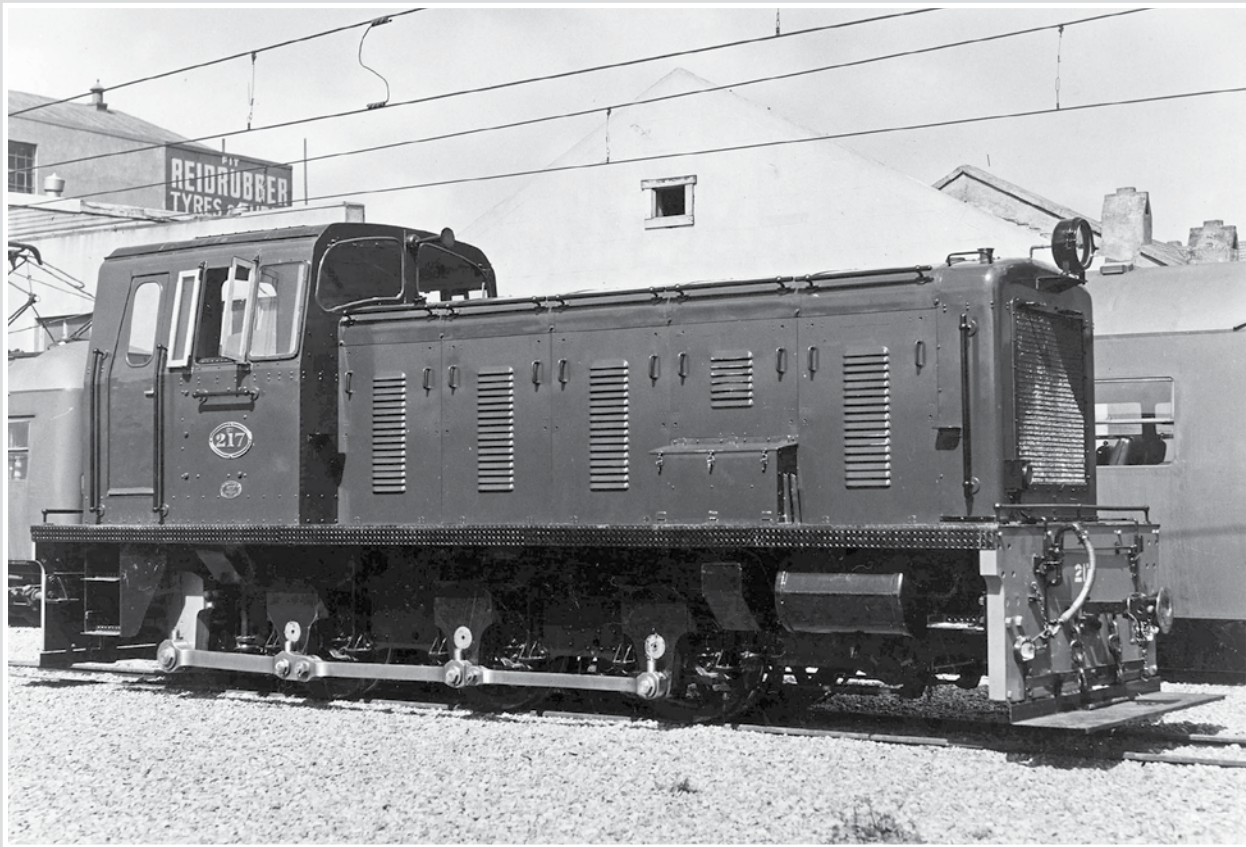
Above. Dsa 217 pictured new at Wellington. Note the off-set position of the cab steps and the small size of the protector plate, features NZR insisted must be changed. NZR Photo AC Bellamy collection.
